ANNUAL REPORT FOR 2011

**Mile Branch
Guilford County
TIP No. R-0609IA**

Prepared By:
Natural Environment Unit & Roadside Environmental Unit
North Carolina Department of Transportation
November 2011

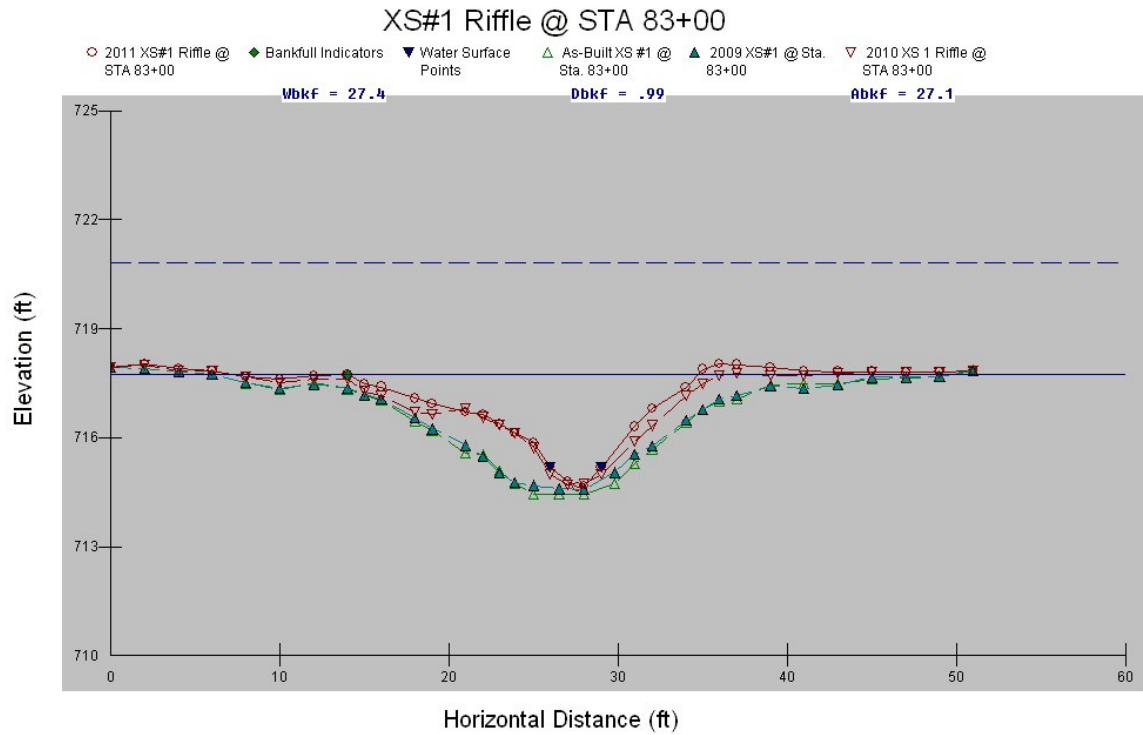
Cross-Section #1 (Riffle) Abbreviated Morphological Summary					
	2009	2010	2011	2012	2013
Bankfull Width (ft)	26.3	26.9	27.4		
Bankfull Mean Depth (ft)	1.4	1.06	0.99		
Width/Depth Ratio	18.8	25.38	27.68		
Bankfull Cross Sectional Area (ft ²)	36.9	28.64	27.14		
Maximum Bankfull Depth (ft)	2.86	2.91	3.09		
Width of the Floodprone Area (ft)	51	51	51		
Entrenchment Ratio	1.94	1.9	1.86

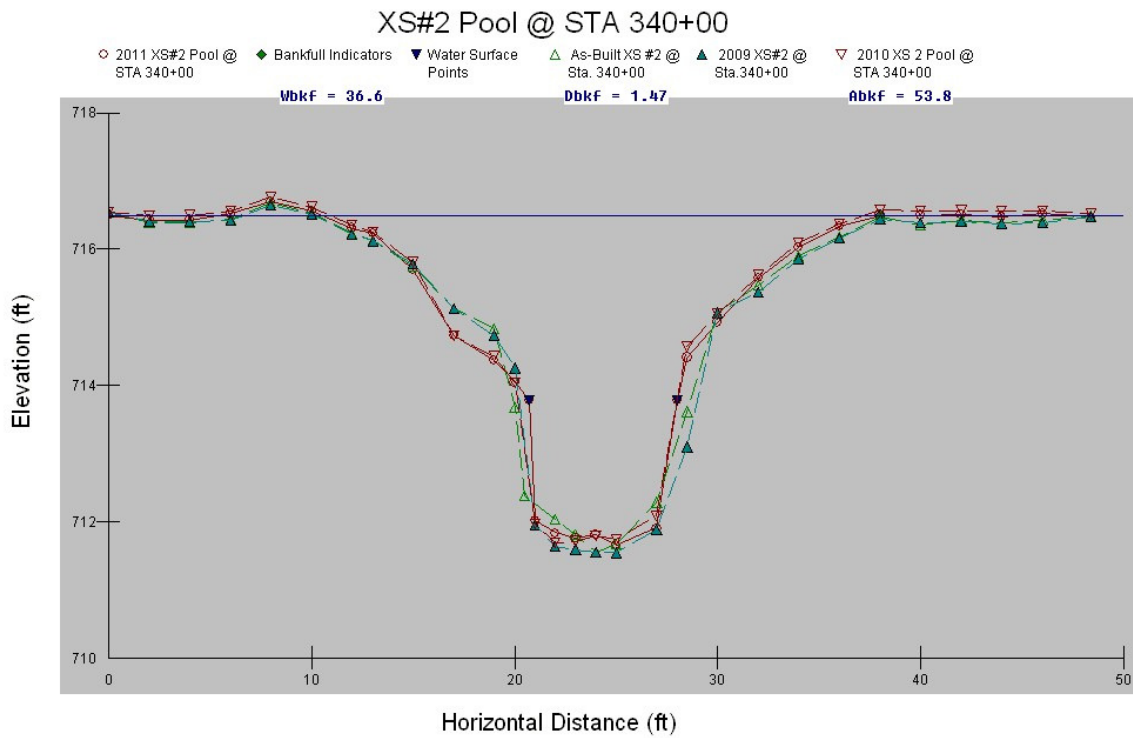
Cross-Section #2 (Pool) Abbreviated Morphological Summary*					
	2009	2010	2011	2012	2013
Bankfull Cross Sectional Area (ft ²)	55	55.65	53.54		
Maximum Bankfull Depth (ft)	4.89	4.89	4.84		
Bankfull Mean Depth (ft)	2	1.26	1.95		
Bankfull Width (ft)	27.52	27.69	27.52

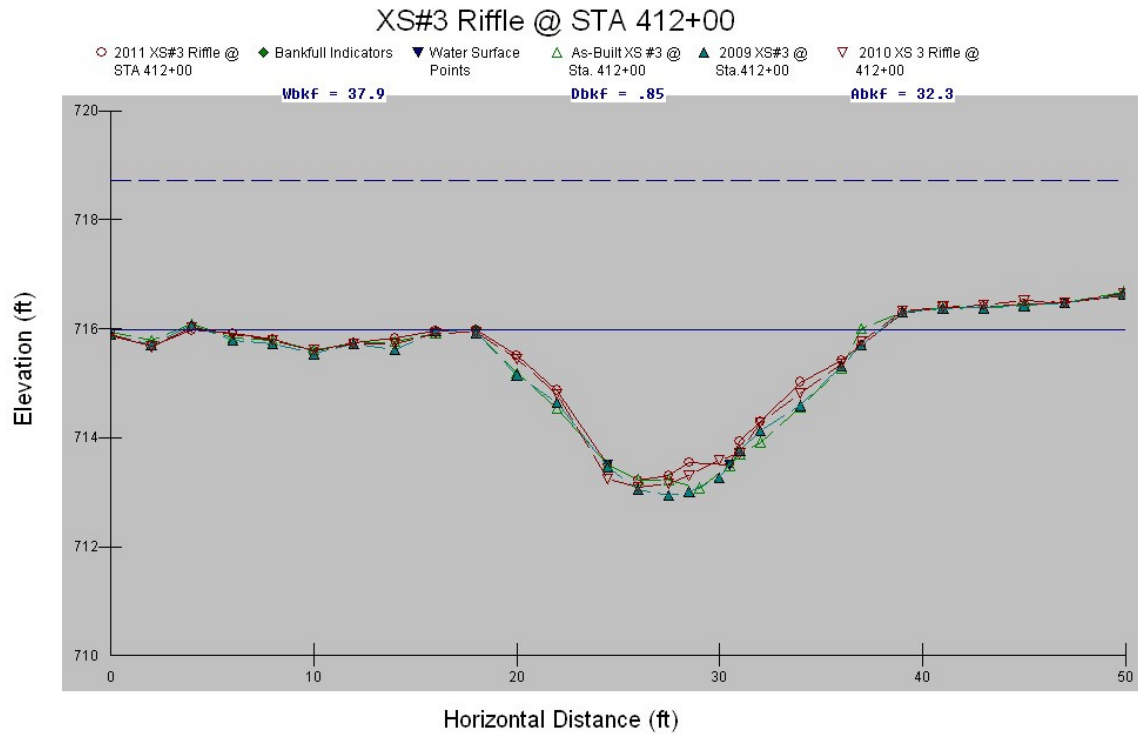
Cross-Section #3 (Riffle) Abbreviated Morphological Summary					
	2009	2010	2011	2012	2013
Bankfull Width (ft)	19.75	19.61	19.93		
Bankfull Mean Depth (ft)	1.68	1.57	1.48		
Width/Depth Ratio	11.76	12.49	13.47		
Bankfull Cross Sectional Area (ft ²)	33.15	30.76	29.6		
Maximum Bankfull Depth (ft)	3	2.84	2.75		
Width of the Floodprone Area (ft)	49.9	49.9	49.9		
Entrenchment Ratio	2.53	2.54	2.5

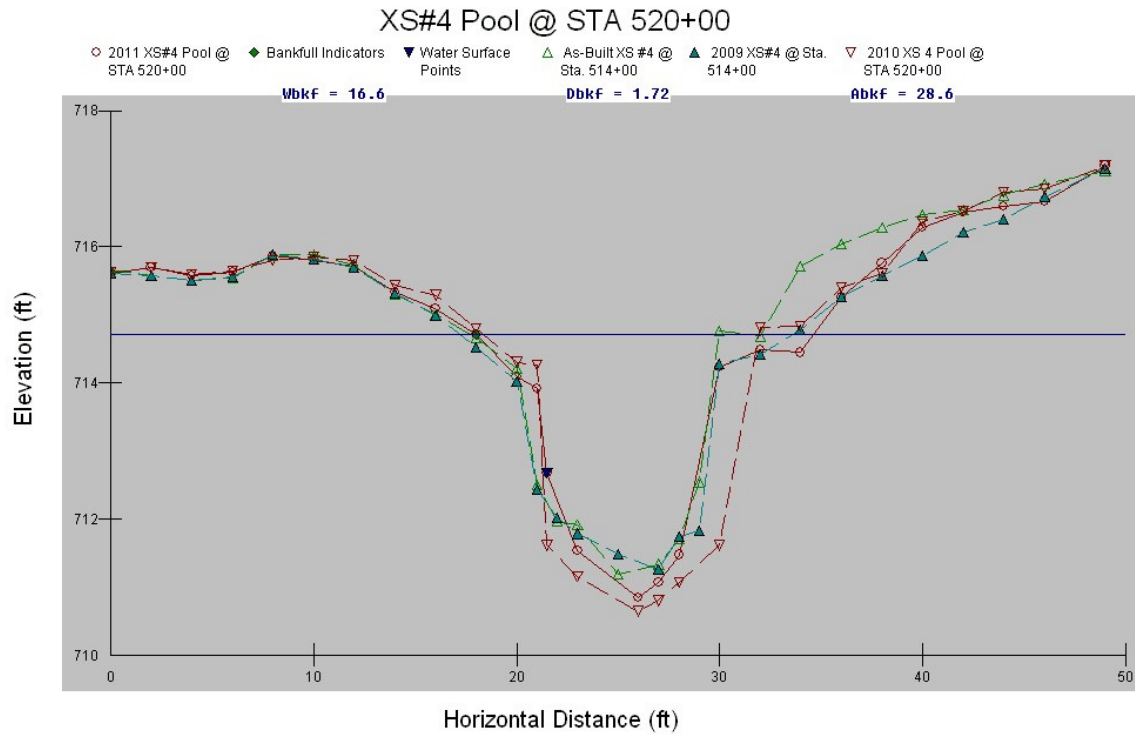
Based on comparisons of the monitoring data, all four cross sections appear stable with little or no active bank erosion. The floodplain on the right bank at Cross Section #4 had to be repaired after the as-built was completed. The right endpin at this cross section had to be reset due again to the latest streambank repairs. The graph of Cross Section #4 shows this layout. Graphs of the cross sections are presented in Appendix A. Future survey data will vary depending on actual location of rod placement and alignment; however this information should remain similar in appearance. The longitudinal profile shows that the channel is stable for the 2011 monitoring evaluation.

Cross-Section #4 (Pool) Abbreviated Morphological Summary*					
	2009	2010	2011	2012	2013
Bankfull Cross Sectional Area (ft ²)	23.18	36.71	28.62		
Maximum Bankfull Depth (ft)	3.02	4.15	3.86		
Bankfull Mean Depth (ft)	2.11	2.62	1.72		
Bankfull Width (ft)	11	14	16.64

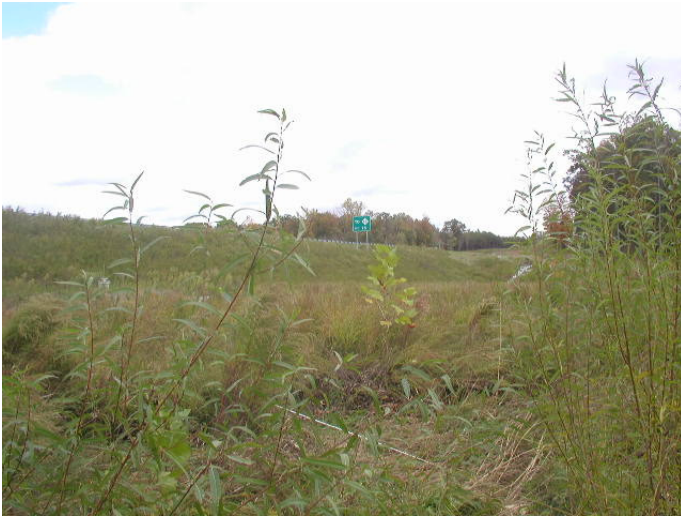
Vegetation Plot #1 taken from Photo Point #1

Plot #	Tulip Poplar	American Sycamore	Green Ash	Willow Oak	Overcup Oak	River Birch	Blackgum	Total (Year 3)	Total (at planting)	Density (Trees/Acre)
1	3	7	15	2			1	28	45	423
2	7	12	9	3	14	5	1	51	55	631
Average Density (Trees/Acre)										527
